## **FRANKLIN COUNTY COMMISSIONERS MEETING AGENDA**

**Calderwood Engineering**

Madrid Twp, Reeds Mill Bridge #5929, WIN N/A  
Reeds Mill Road over Orbeton Stream

Highway Bridge Inspection Report

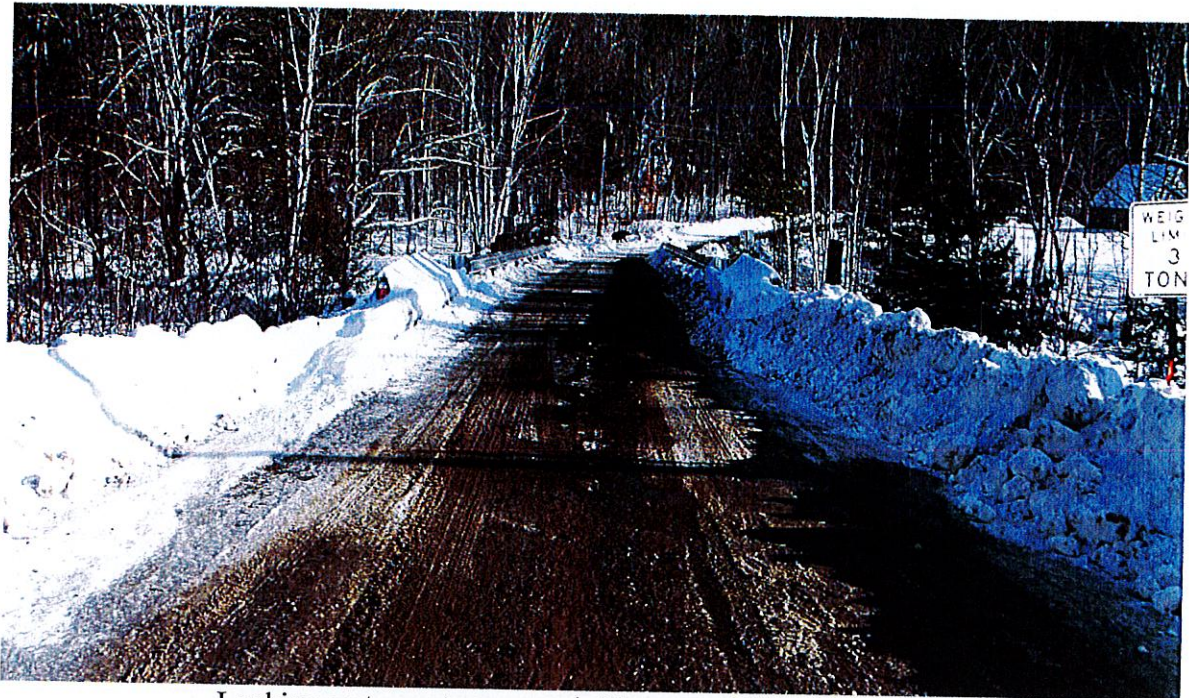
Looking east over temporary bridge, note built-up snowbanks

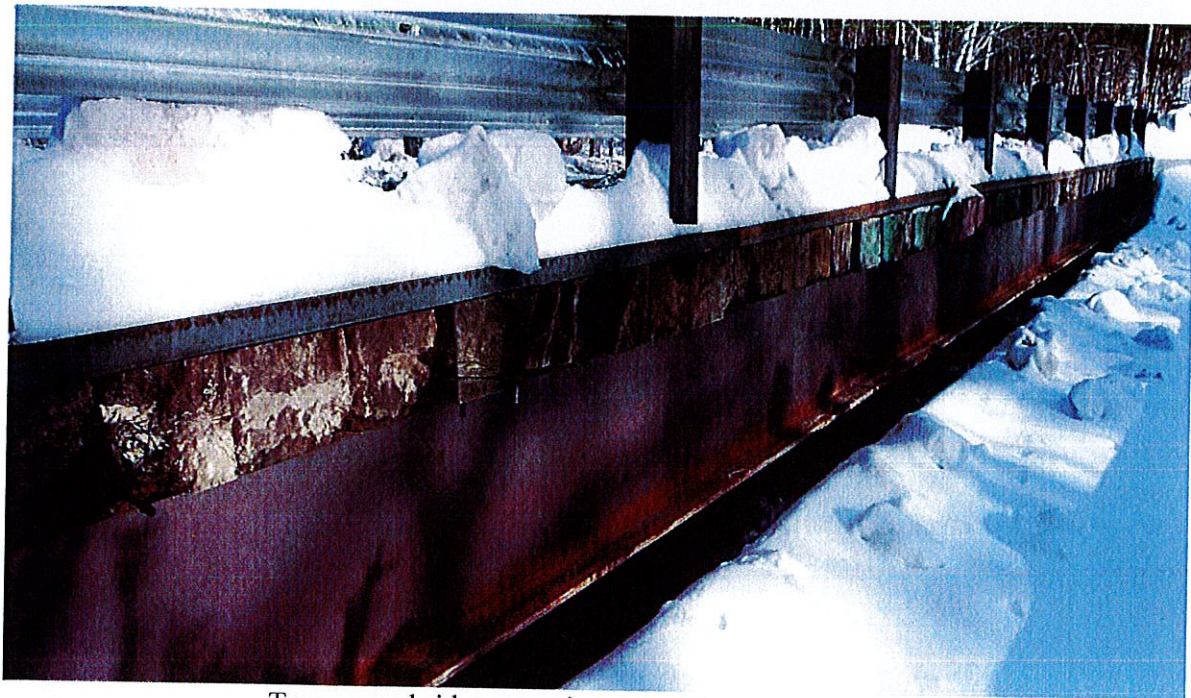
Temporary bridge spanning over existing bridge deck

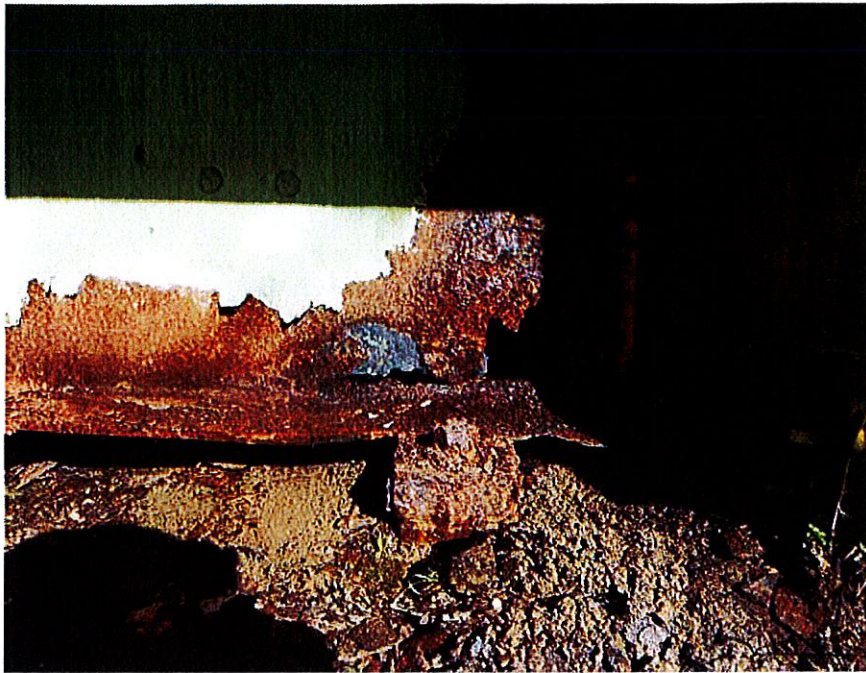
**GENERAL CONDITION:** Steel beams are in critical condition with severe section loss at beam ends. The superstructure is rated a "2" due to the beam ends condition.

Existing beam ends, note contortion, up to 100% section loss, damage is typical all beam ends

**MAINTENANCE PROBLEMS:** Repair beam ends and bearings. Grout repair/ fill voids between abutment stones. Repair damaged approach guardrail.

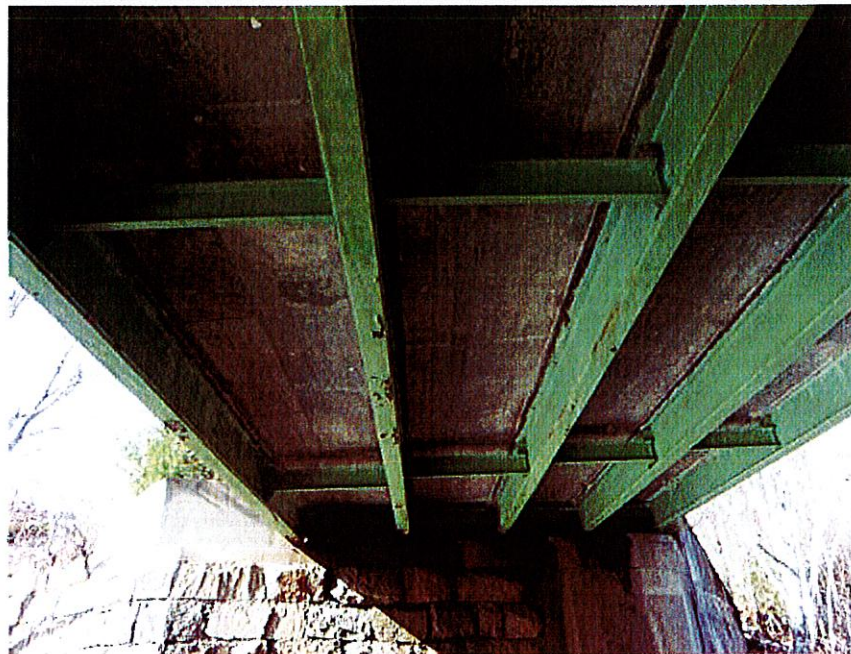
Underside of existing deck

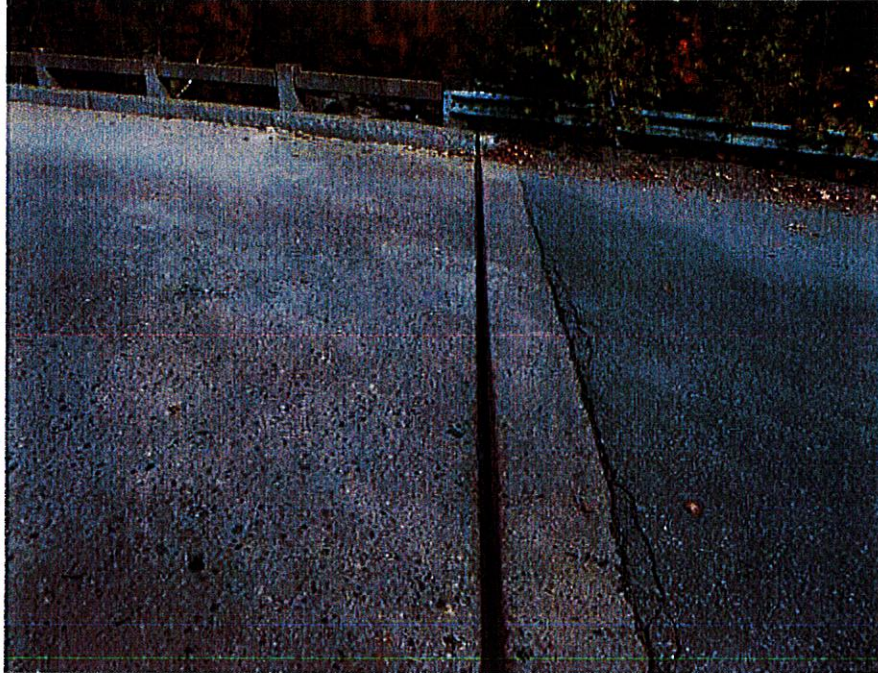
PHOTO 9

Description East deck joint with missing seal

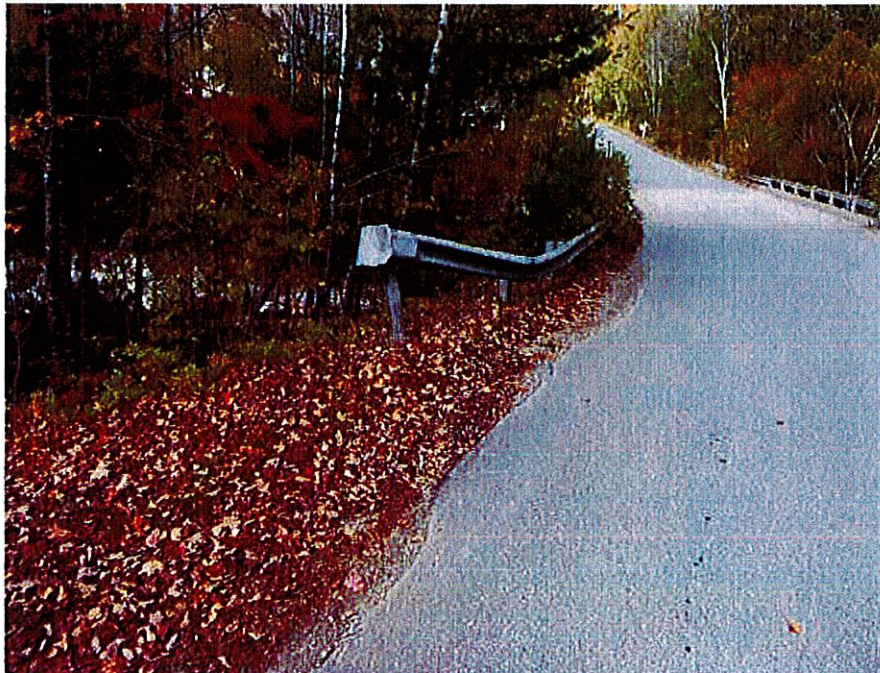
PHOTO 10

Description SE trailing rail damage

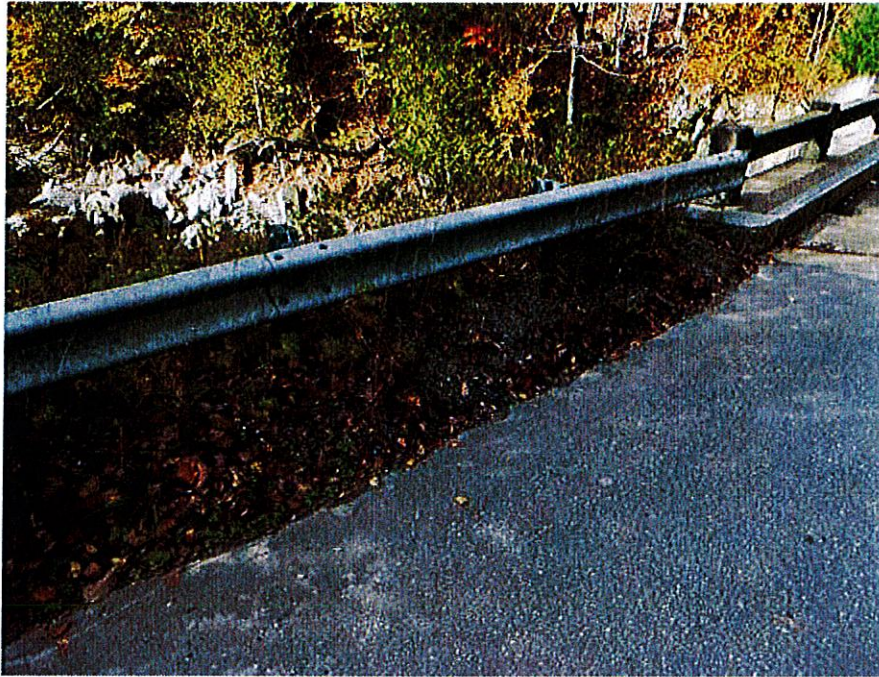
PHOTO 11

Description Overfill under approach rails

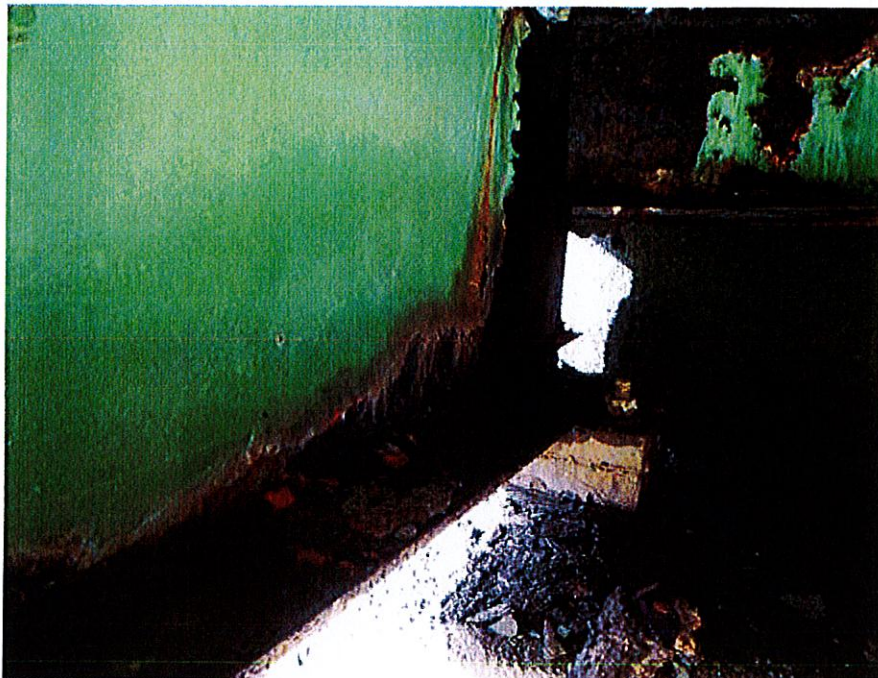
PHOTO 13

Description West abutment Beam end 1, stiffener section loss and bottom flange thinner over bearing

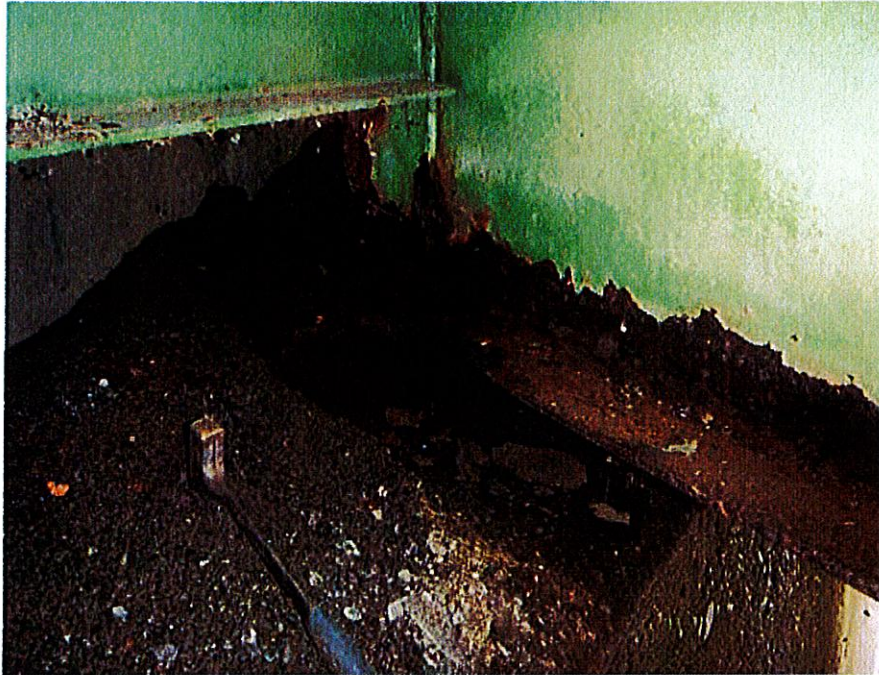
PHOTO 15

Description West abutment Beam end 3, DS side with bottom flange section loss and web behind bearing

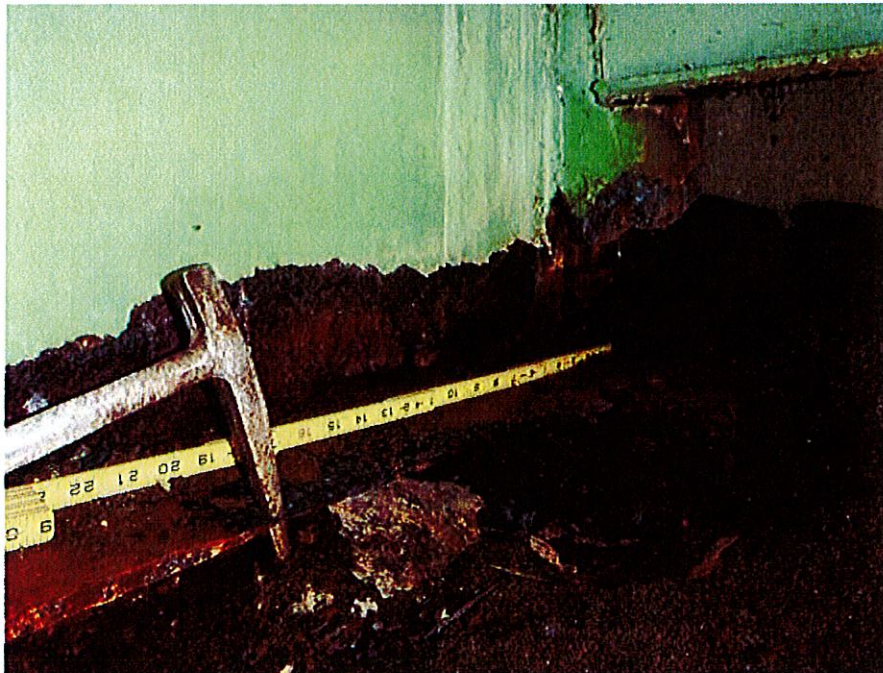
PHOTO 16

Description West abutment Beam end 3, US side with bottom flange and web behind bearing section loss

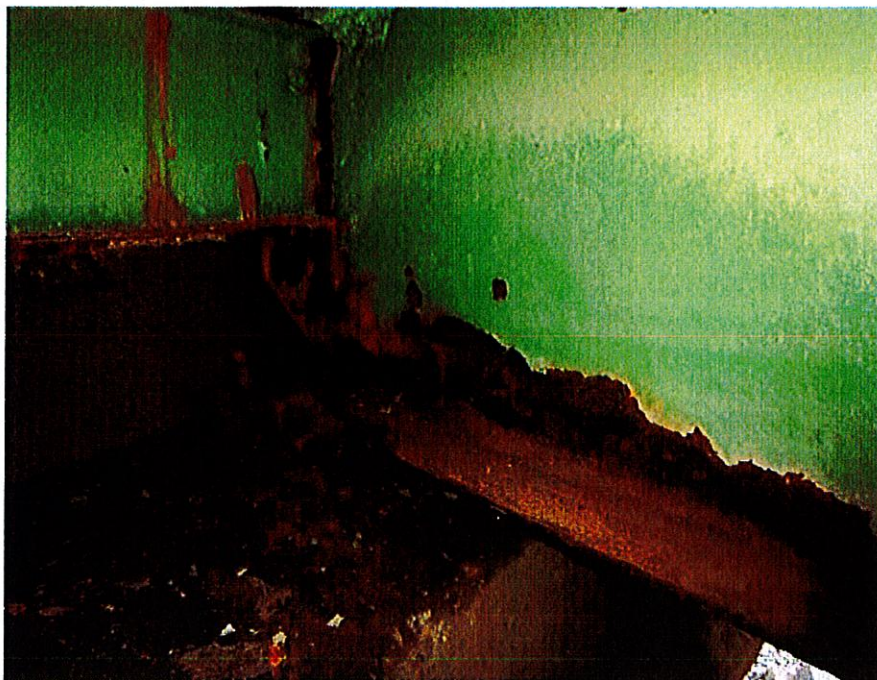
PHOTO 17

Description West abutment, DS side of Beam end 2 with holes in web and flange

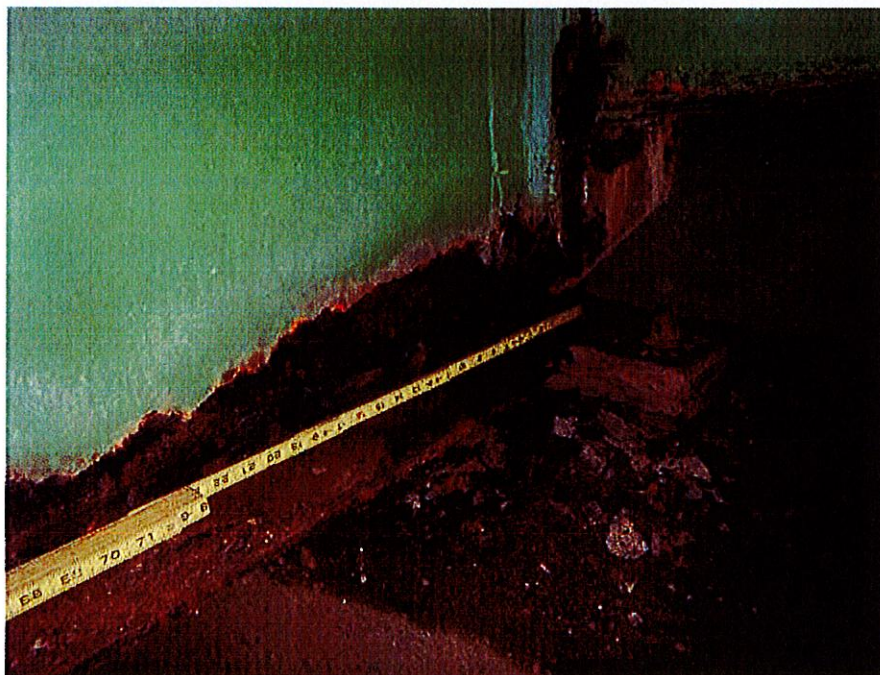
PHOTO 18

Description West abutment, US side of Beam end 2 with holes in web

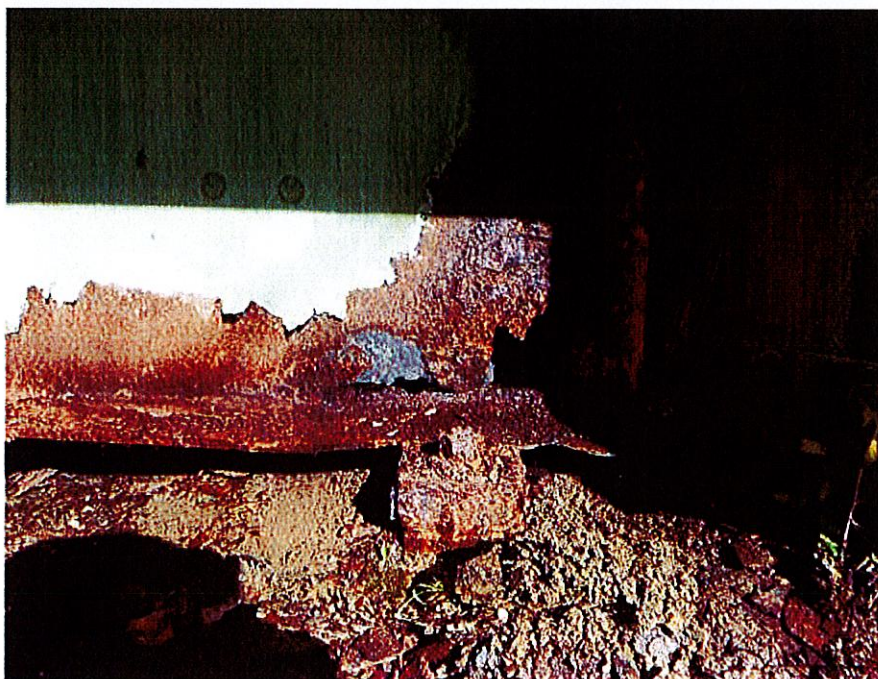
PHOTO 22

Description East abutment Beam end 1 with section loss, crushing and distortion

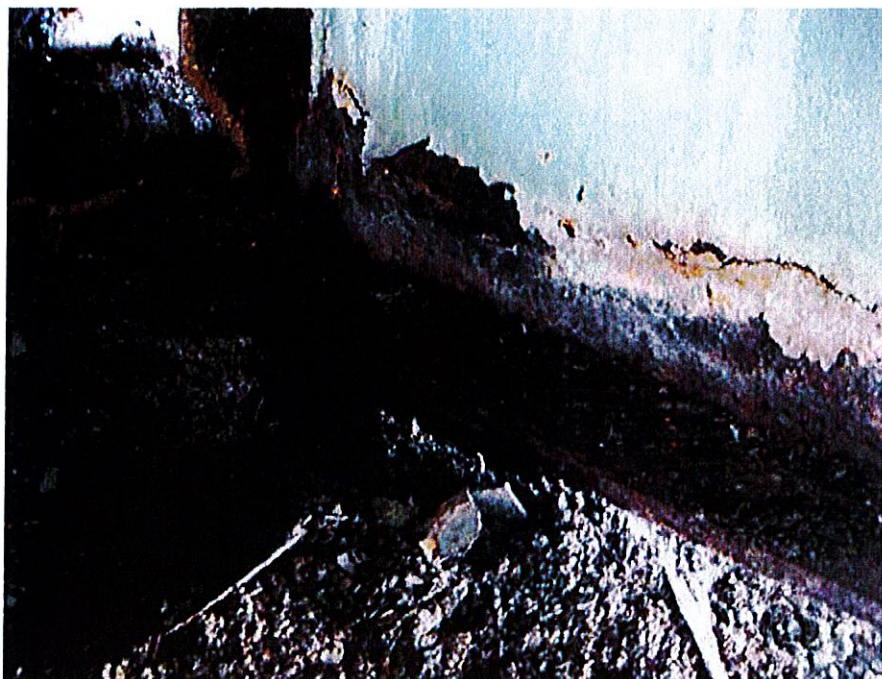
PHOTO 23

Description East abutment Beam end 3 with half thickness of bottom flange

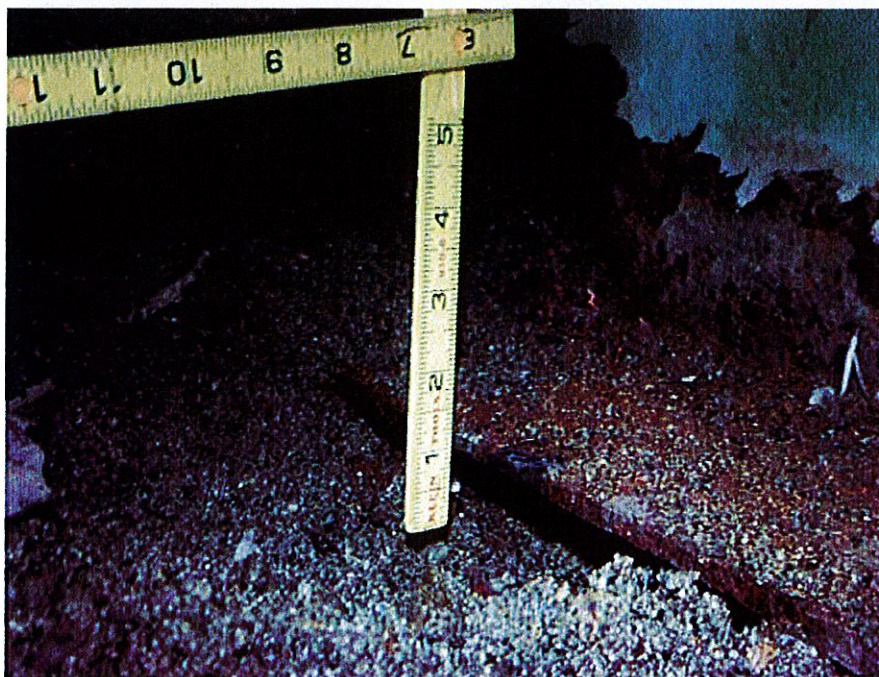
PHOTO 24

Description East abutment Beam end 4 with three sixteenth bottom flange

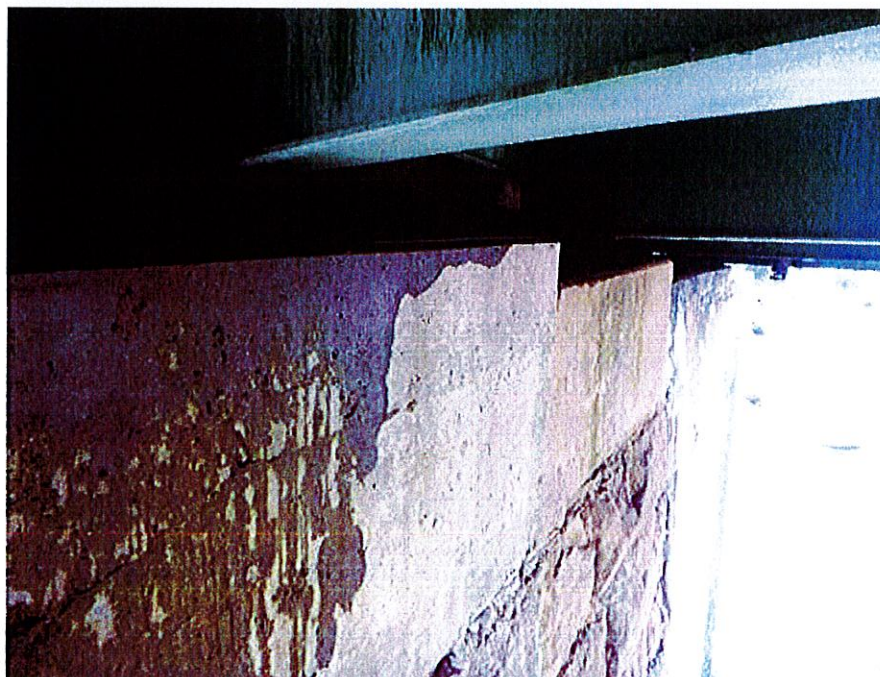
PHOTO 26

Description East abutment bearings covered in sand

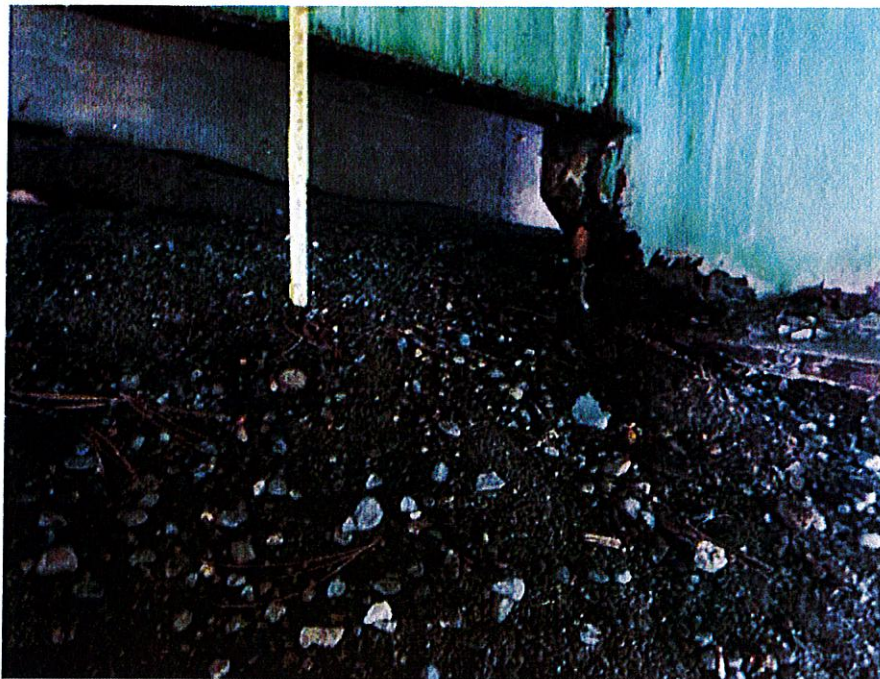
PHOTO 27

Description East abutment sand 7 - 12 inches deep

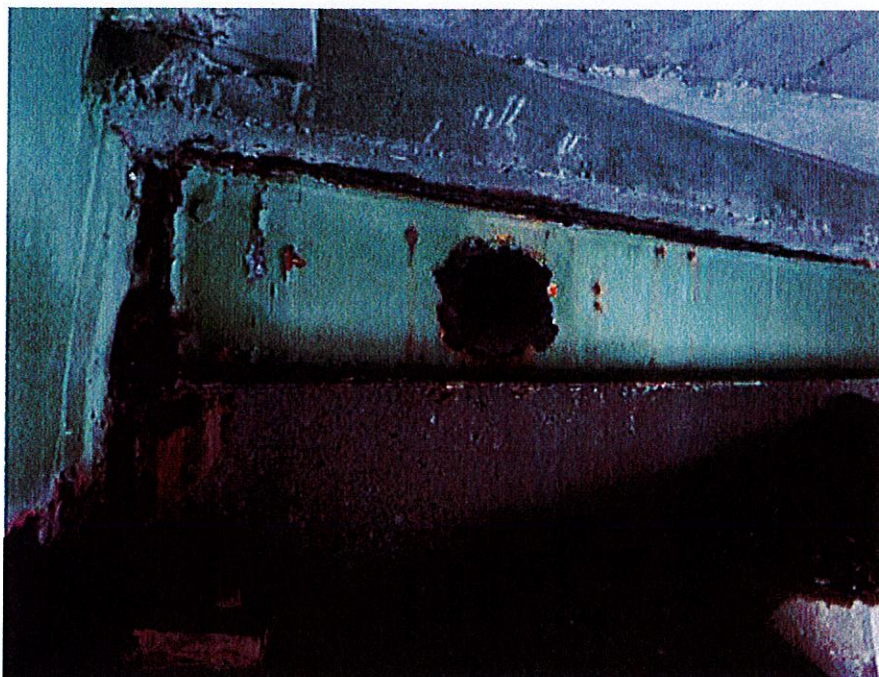
PHOTO 28

Description Hole in diaphragm, west abutment between Beam ends 2 and 3

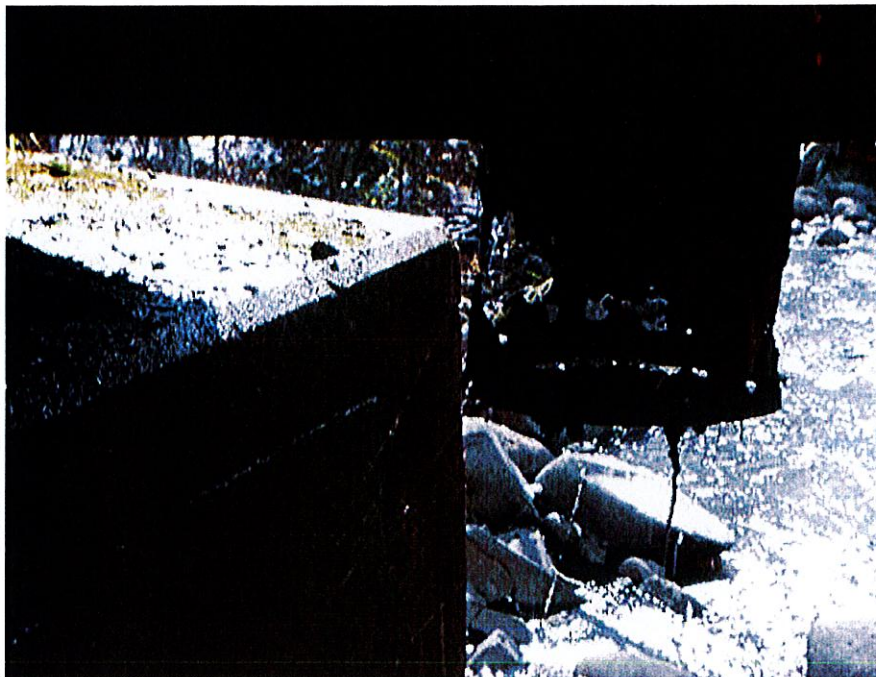
PHOTO 29

Description Holes in deck drain extension

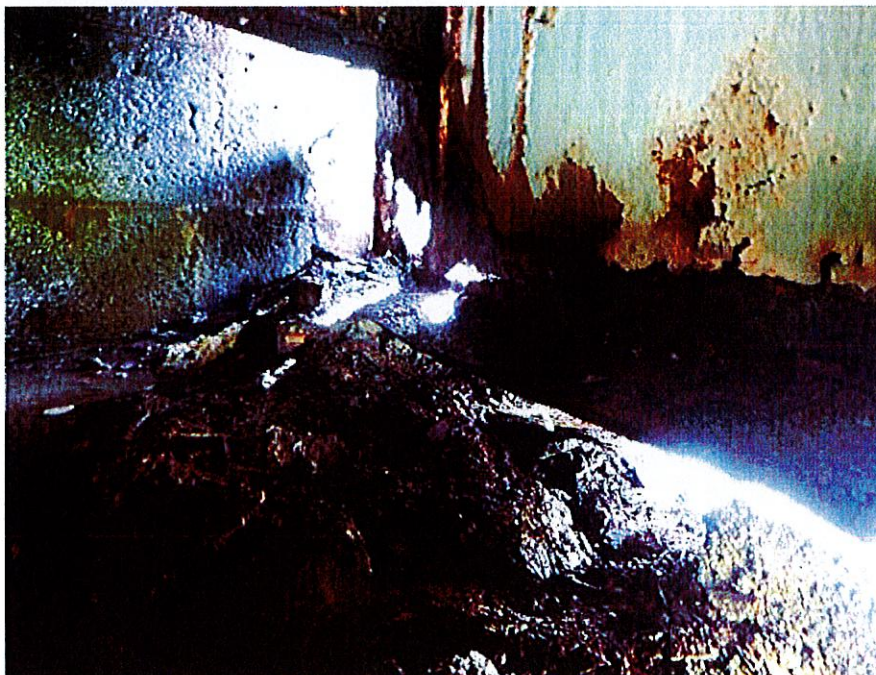
PHOTO 30

Description Inside of east abutment Beam end 1 with holes, crush and distortion

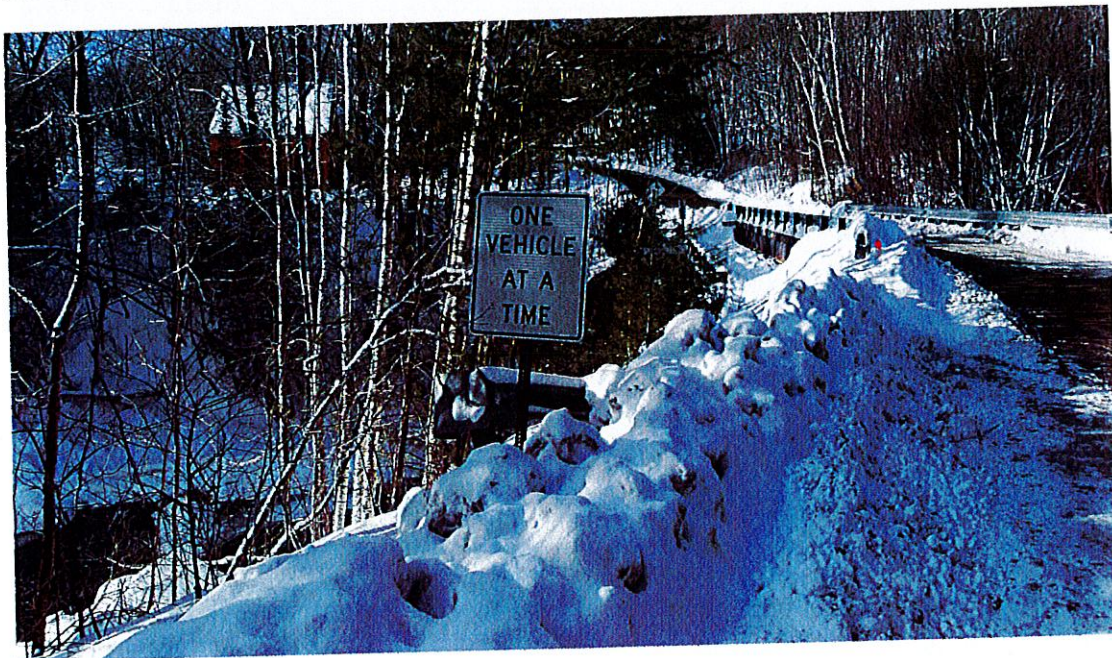
PHOTO 2

Description 'One Vehicle at a Time' sign on East approach only.

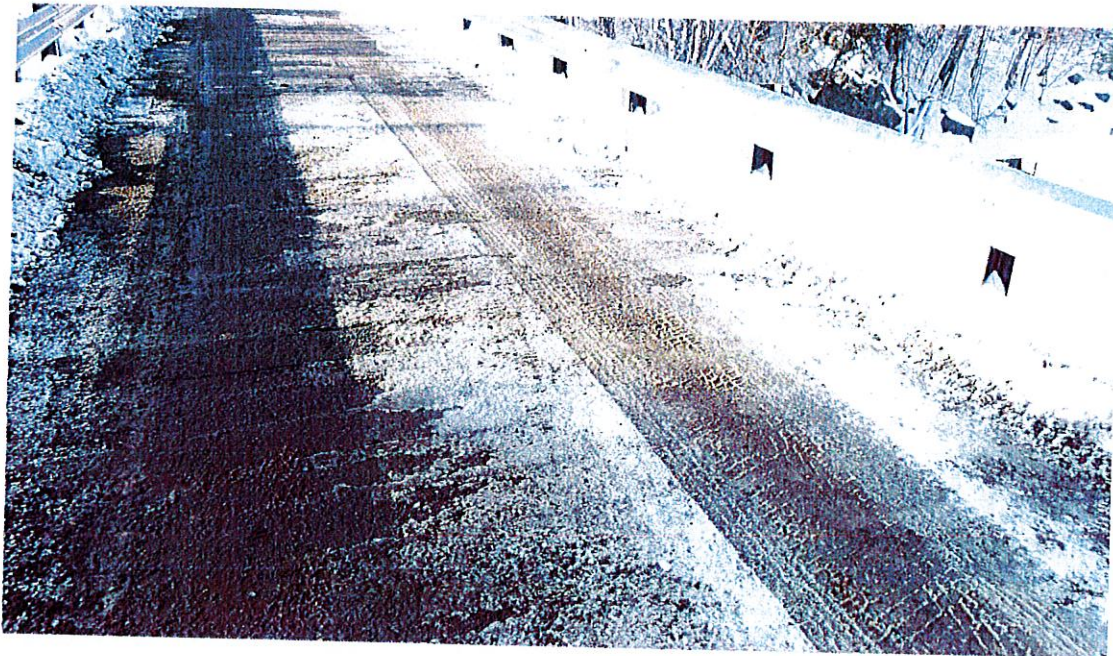
PHOTO 4

Description Timber deck/ wearing surface is in good condition.

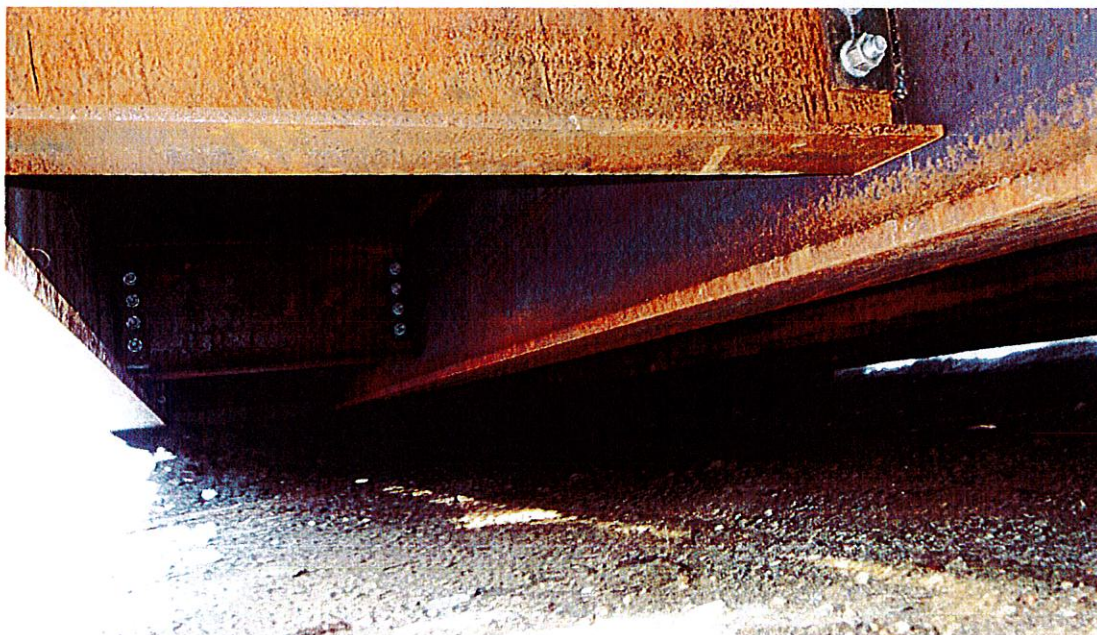
PHOTO 12

Description Concrete block abutments and bearings are not visible under bridge.
