# Report on Sandy River Watershed

## Regional Forums

## Executive Summary

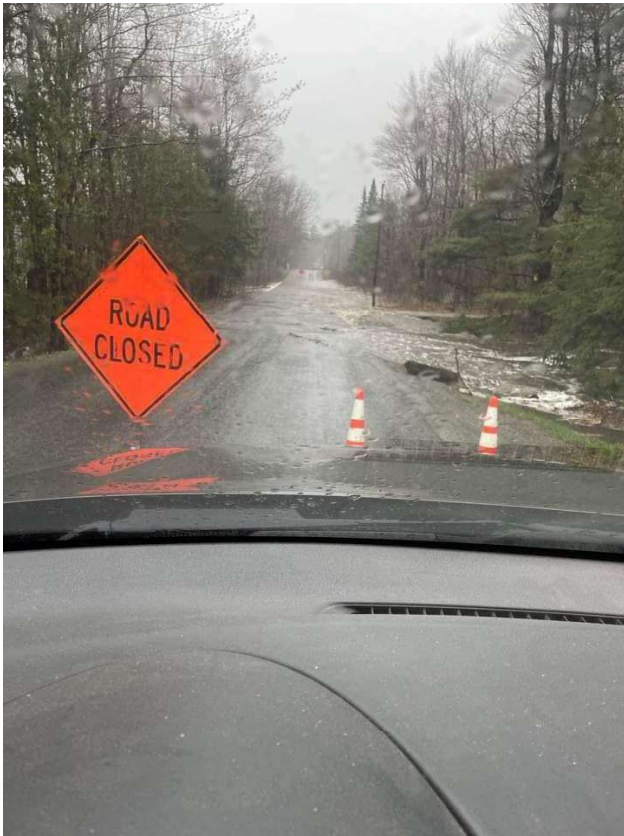
*Figure 12. May 2023, Facebook Post by Geneva Asselin showing flooding on Route 143/43 Sandy River rd.*

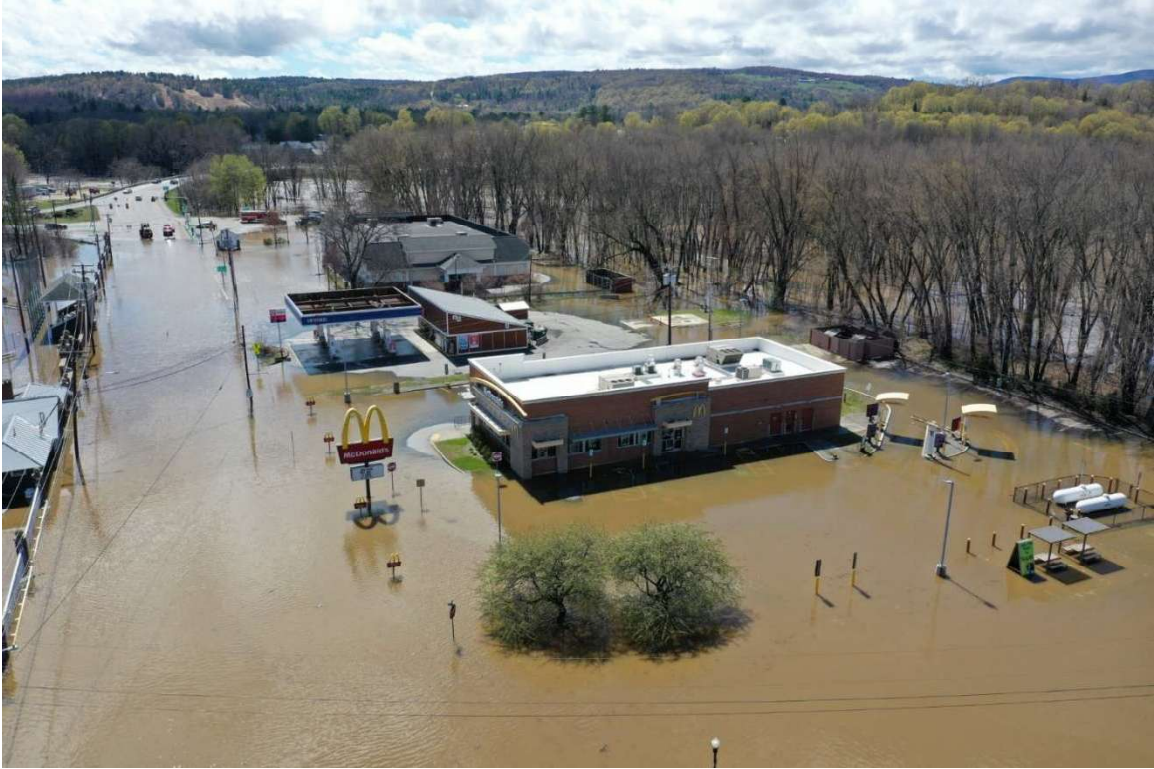
*Figure 14. May 2023, Main Street Farmington. Photo credit Matt Billian.*

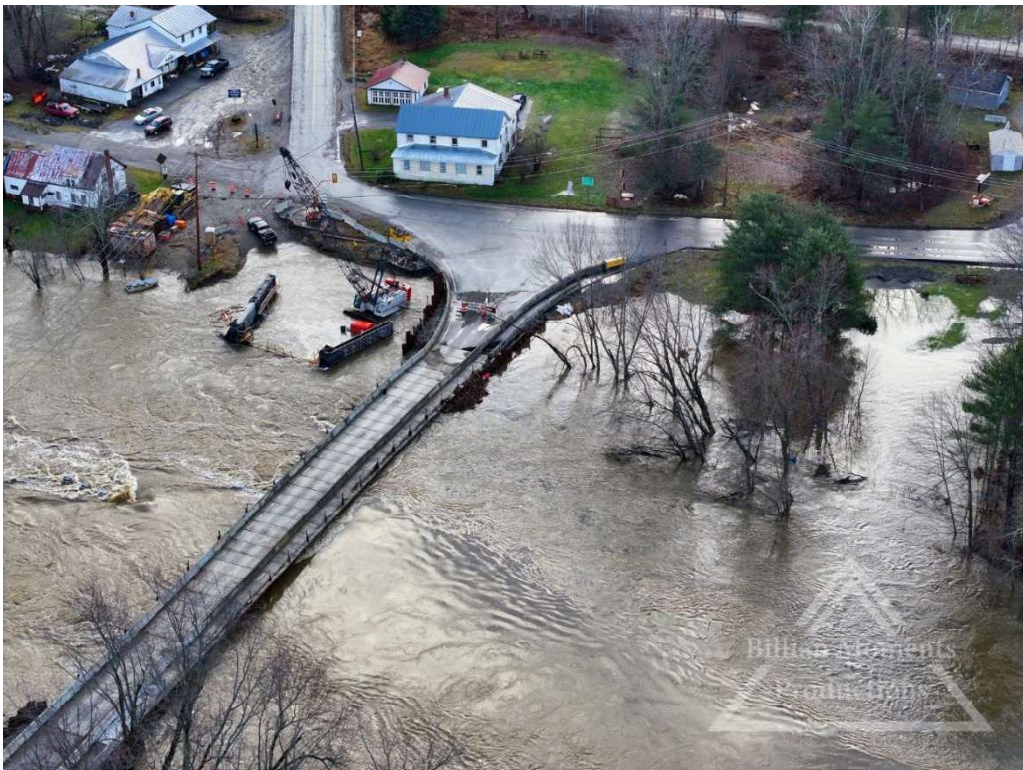
*Figure 15. December 2023, Farmington Falls bridge. Photo credit to Matt Billian.*
