## **FRANKLIN COUNTY COMMISSIONERS MEETING AGENDA**

**Calderwood Engineering**

Madrid Twp, Reeds Mill Bridge #5929, WIN N/A  
Reeds Mill Road over Orbeton Stream

Highway Bridge Inspection Report

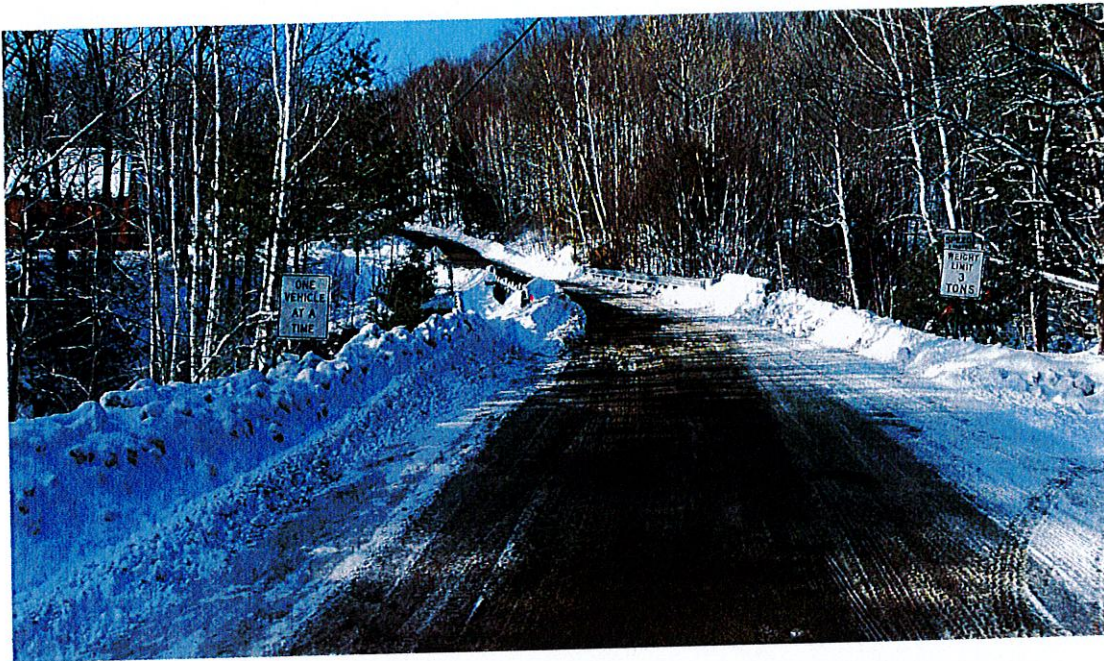
PHOTO 1

Description Looking West over bridge.

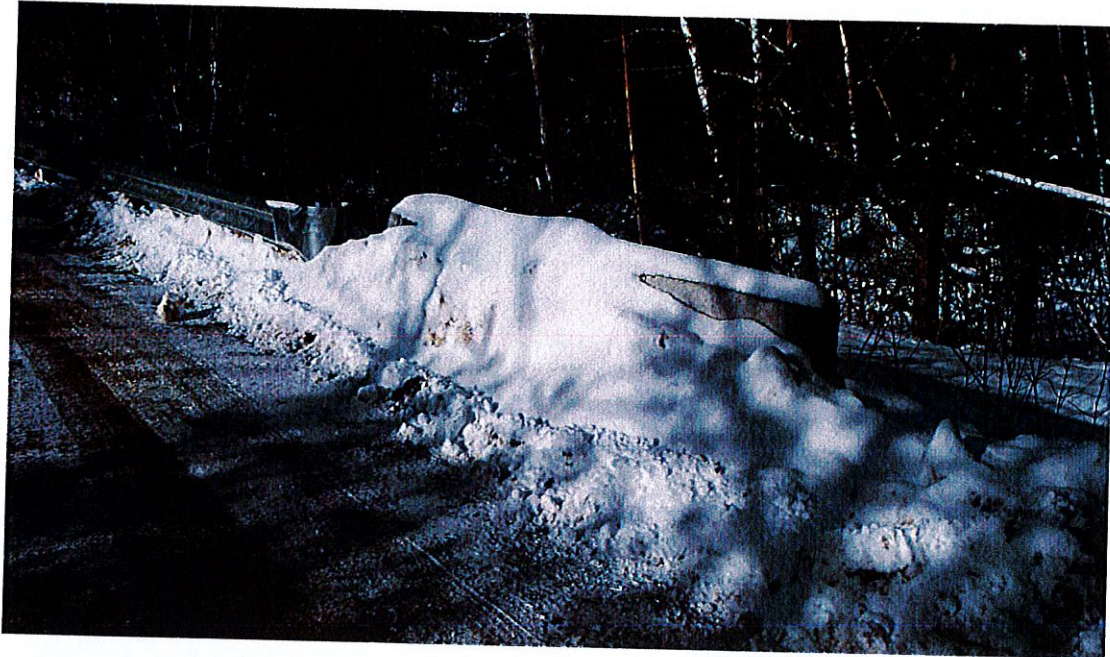
PHOTO 3

Description 10-foot concrete jersey barrier typical on all four corners.

Type	Work Item	Priority	Notes
Maintenance	Paint		Paint unpainted steel superstructure
Maintenance	Repair Approach Guardrail		Remove Jersey barrier and attach approach guardrail to bridge
Maintenance	Rehab Substructure	3	Grout repair/ fill voids between stones as needed.
Maintenance	Cut Brush		
Maintenance	Remove Overfill

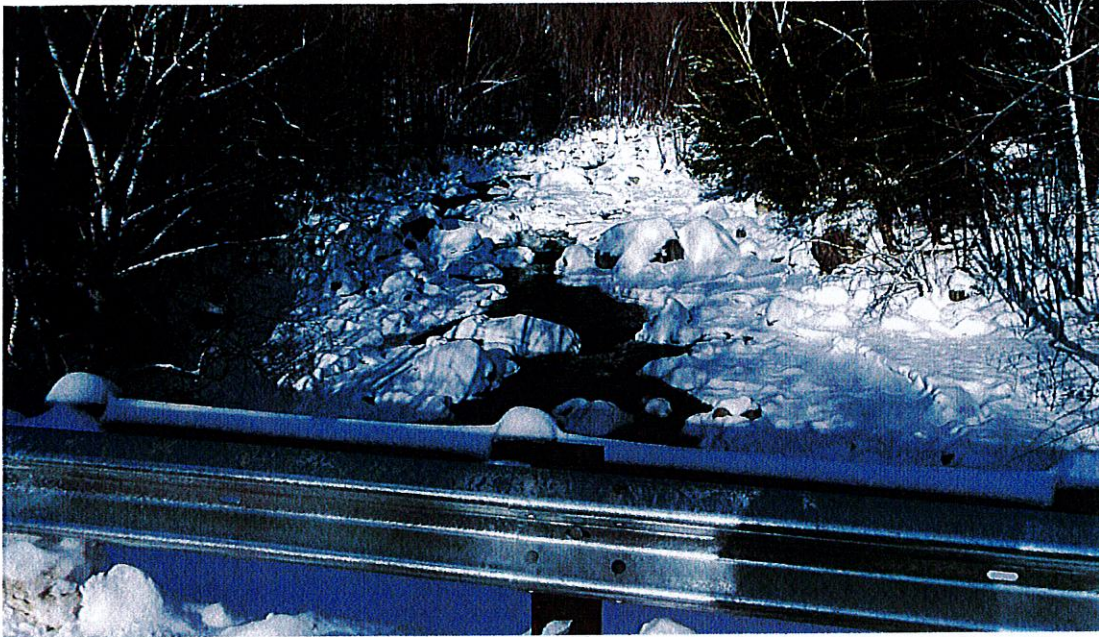
PHOTO 5

Description Looking upstream and North from bridge deck.

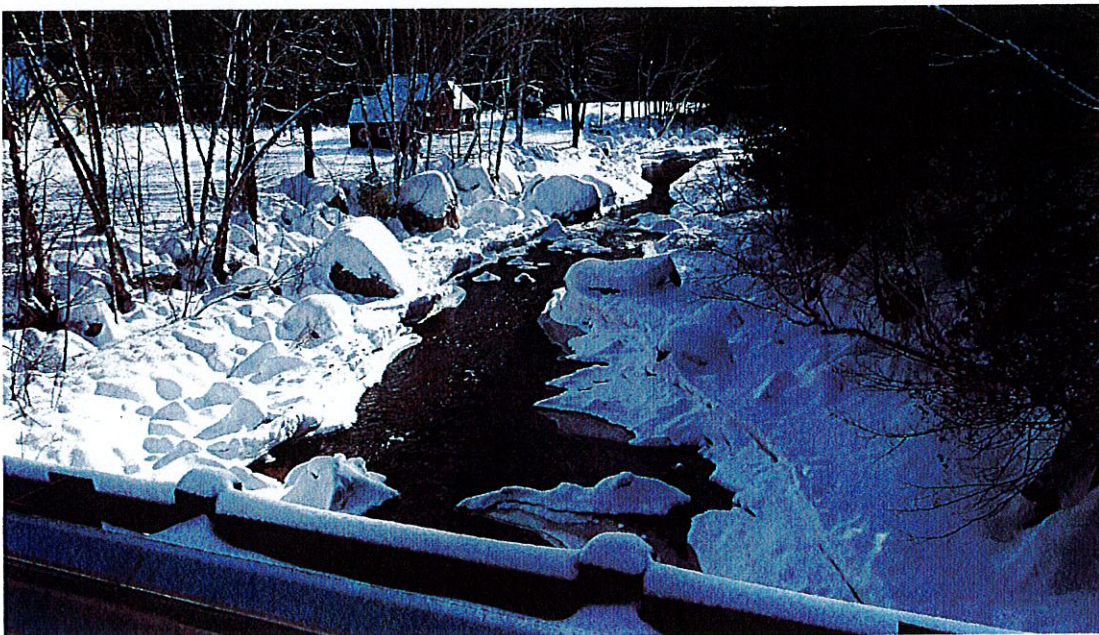
PHOTO 6

Description Looking downstream and South from bridge deck.

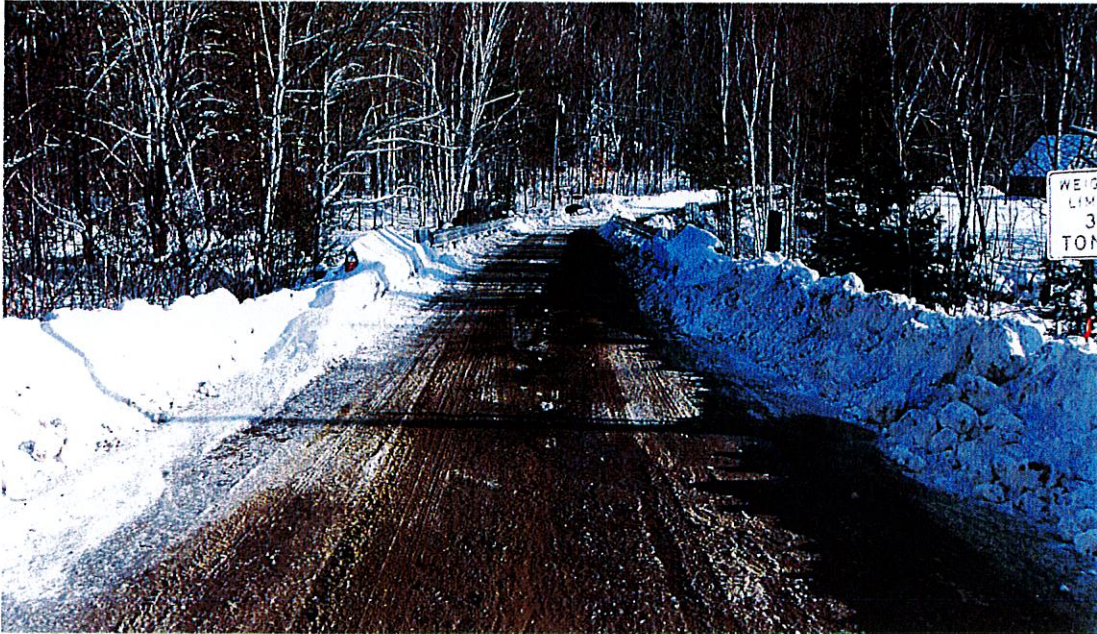
PHOTO 7

Description Looking East over bridge.

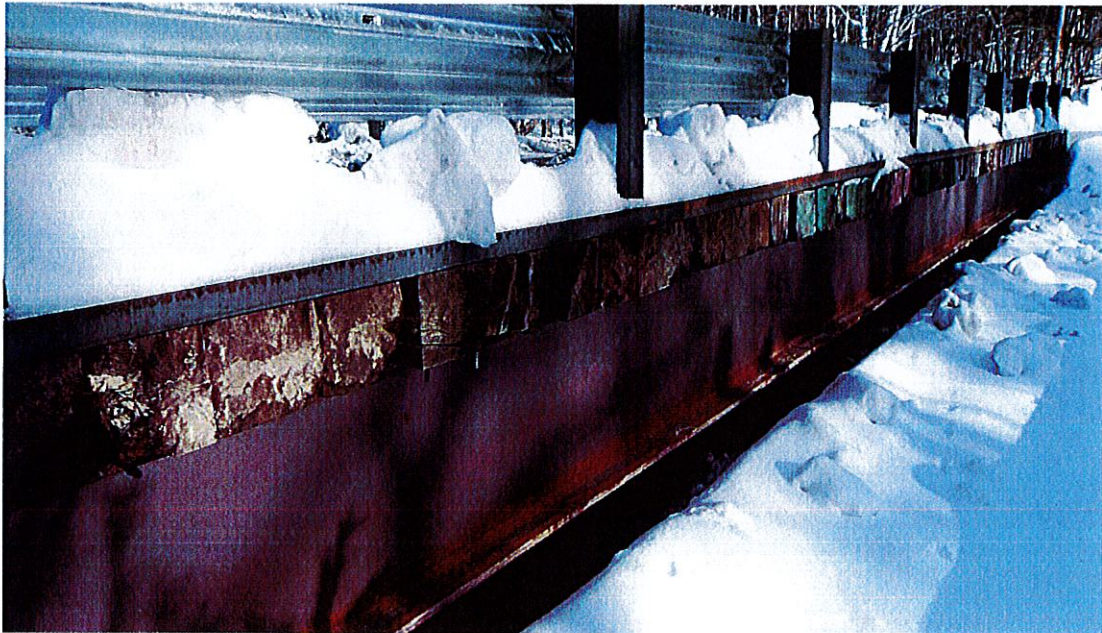
PHOTO 8

Description Looking Northeast at the downstream face of superstructure.

Girders are in poor condition due to the beam ends at bearing areas. Bearings and girder ends have heavy rusting. Girder ends have holes thru, knife edge bottom flanges and section loss to webs at bearing areas. End diaphragms have scattered areas with holes thru and heavy rusting.

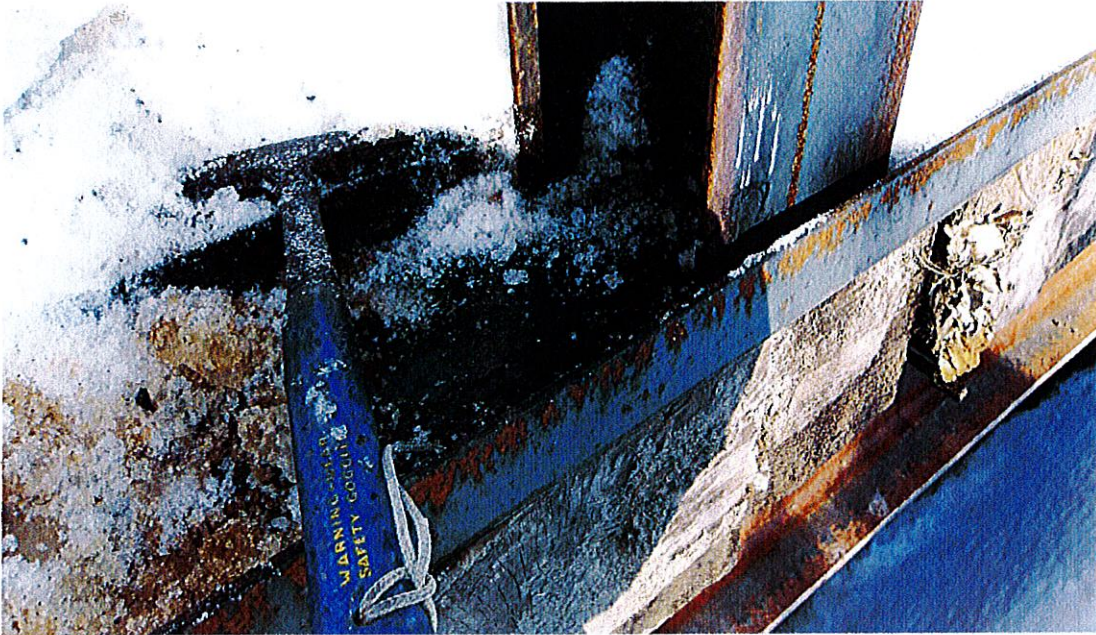
PHOTO 9

Description 6x6 rail post welded to 2x8 channel, channel bolted through timber deck.

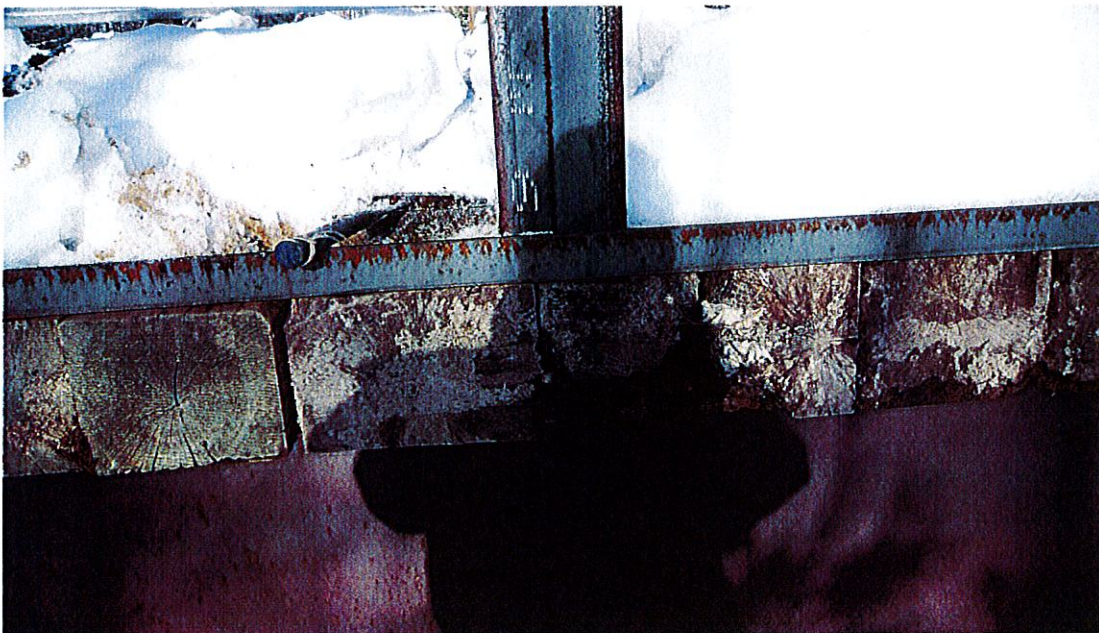
PHOTO 10

Description 8x8, 8x10, and 8x12 deck timbers.

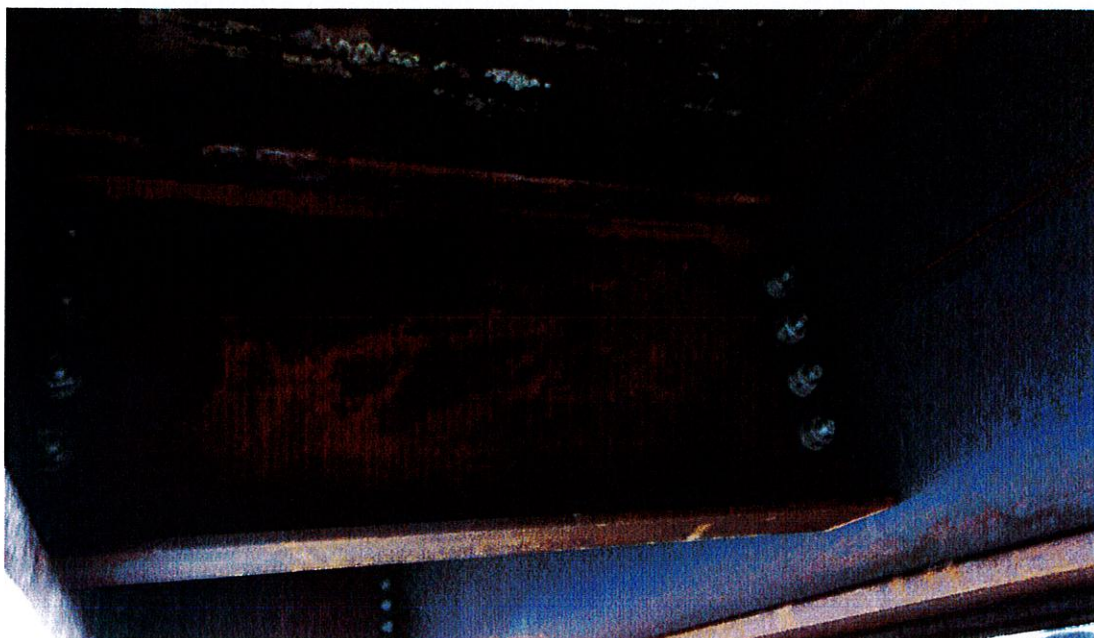
PHOTO 11

Description View of diaphragm.

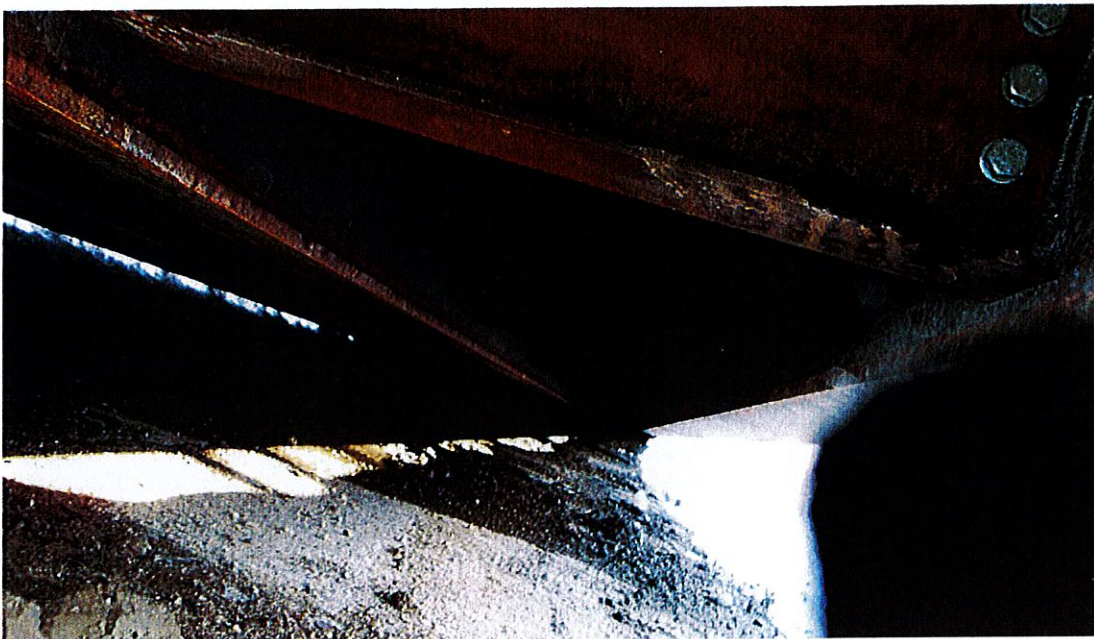
PHOTO 13

Description Looking East under superstructure.

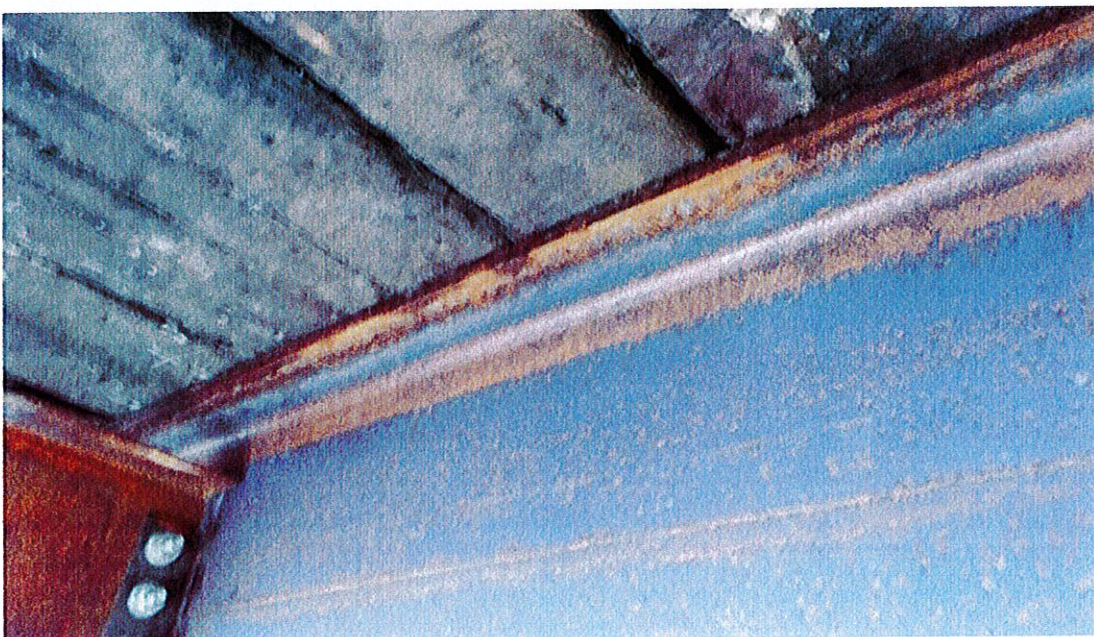
PHOTO 14

Description View under timber deck.

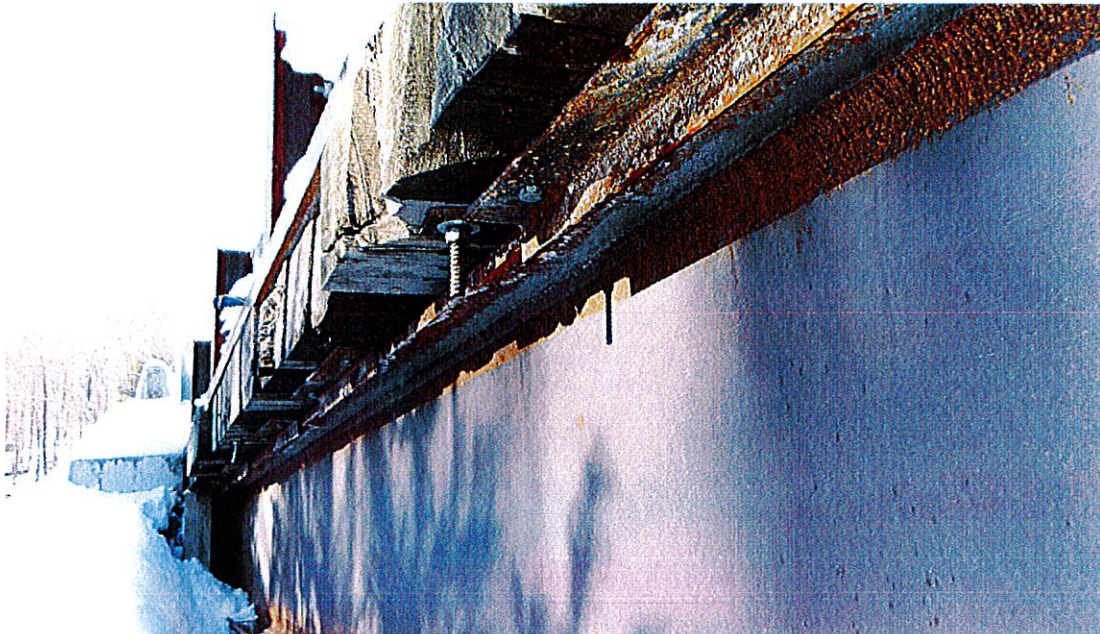
PHOTO 15

Description Lag bolts through angle iron anchoring deck timbers.

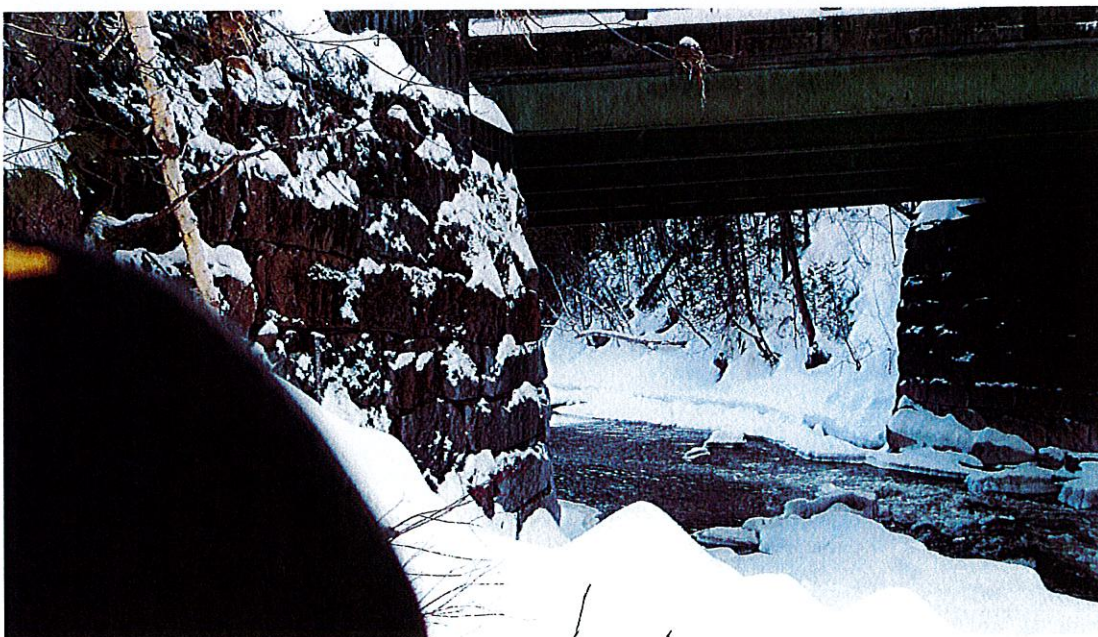
PHOTO 18

Description Looking downstream under bridge.

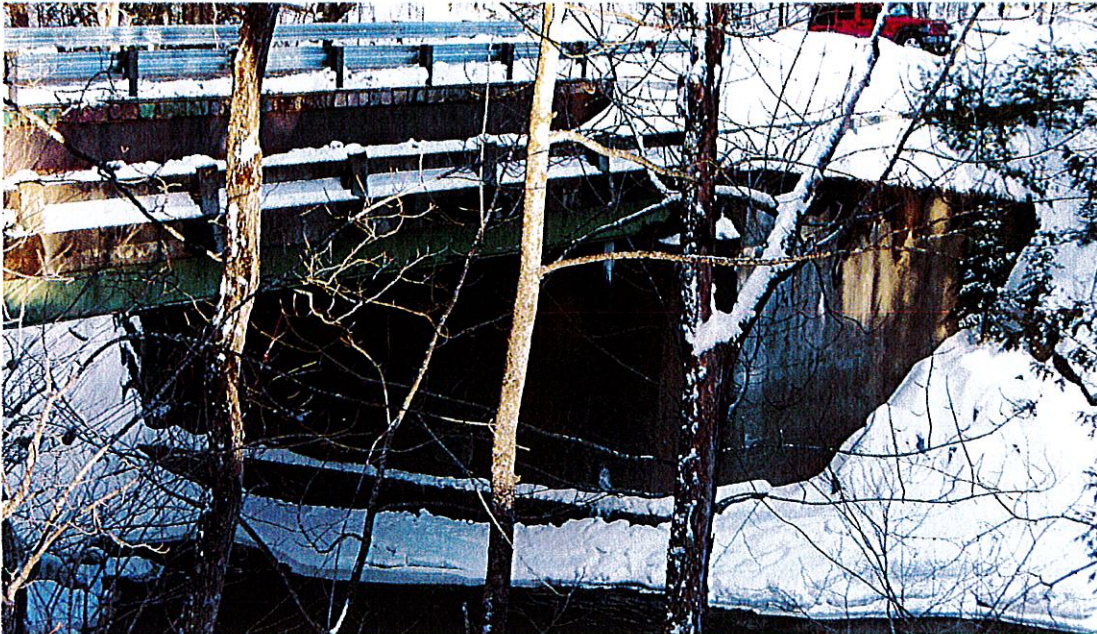
PHOTO 19

Description View of East abutment.

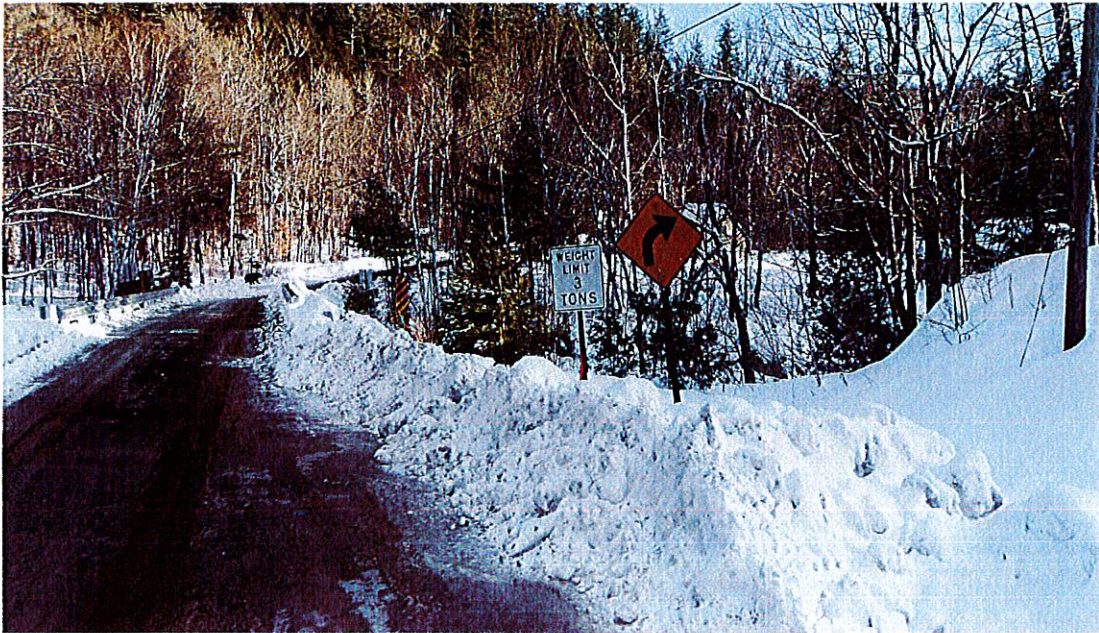
PHOTO 20

Description Looking East over bridge.
